Hanwell Little Recreation Building

Condition Assessment and Visioning

Project J20219

HERITAGE STANDING INC.

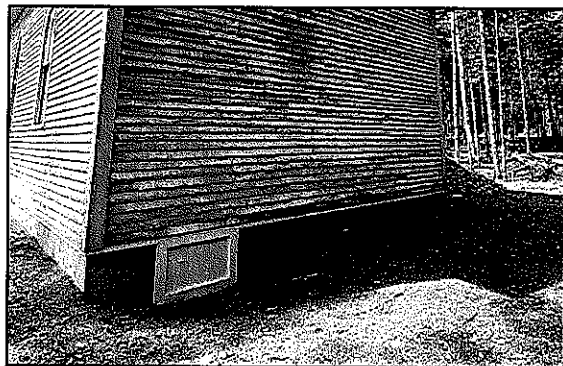
Figure 3: Basement hatch

The building site was found to be in **good** condition. Drainage around the basement hatch at the north end of the building should be improved.

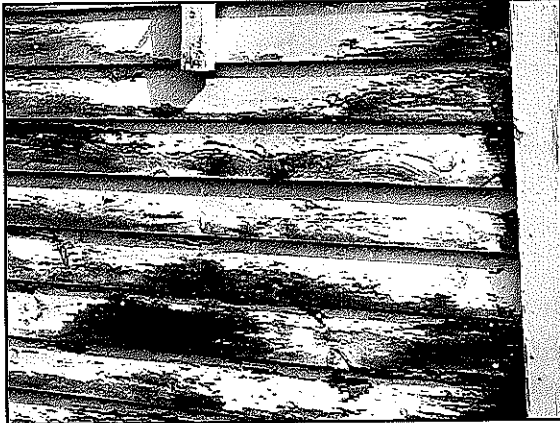
Figure 4: South face paint detail

The exterior walls were found to be in **fair** condition. They will need paint in the next few years.

Use of traditional linseed oil paint, such as those supplied by Brouns & Co. Linseed Oil and Paint, or by Allback Paints through Sage Restoration, should be considered. Although they would cost more initially they provide a longer service life for this type of construction and wood, with organizations such as Parks Canada using the product on their historic buildings. Alternately, standard commercial paints will need to be selected to be compatible with the aided clapboard wood and base layers.

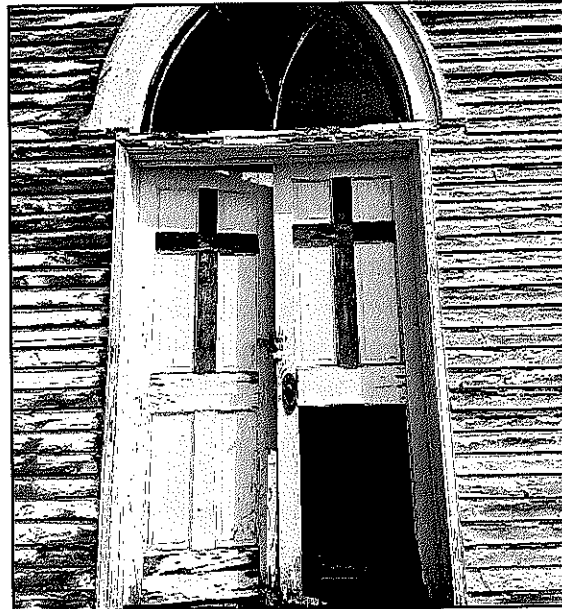
Figure 5: Entrance door damage

The windows, doors, and hatches were found to be in **poor** condition.

The doors and door frame will require likely replacement. Windows and hatches are in good enough condition for repair.

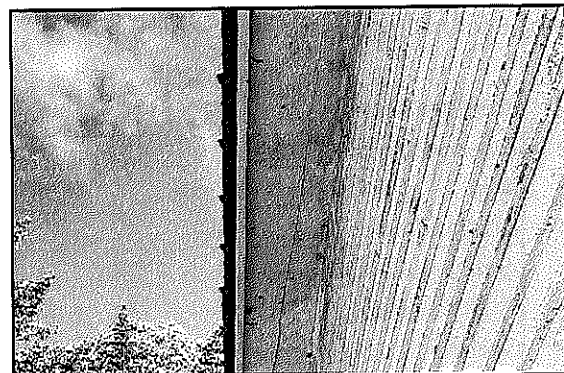
Figure 6: West wall soffit

At the time of the visual inspection, the roof was in **excellent** condition, but the soffits and trim elements were in **fair** condition and will require repair in the coming years.

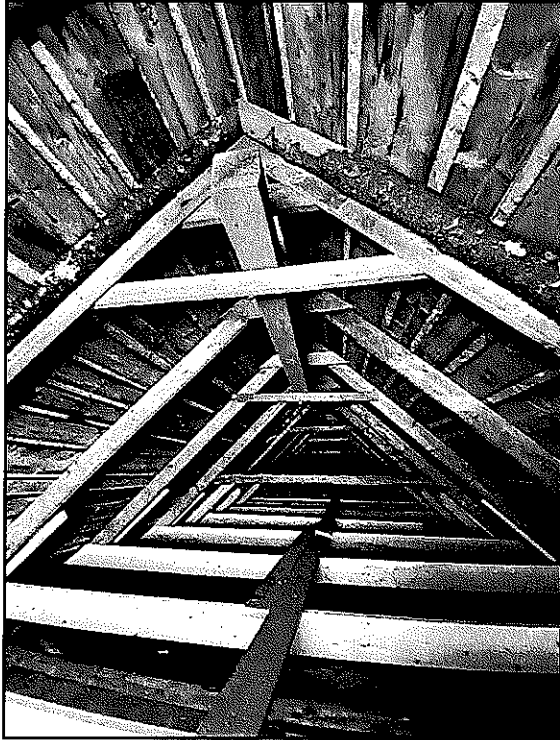
Figure 7: Roof structure

Based upon visual inspection and evaluation the roof structure was found to be in **poor** condition.

If improved insulation is added below the roof, the potentially increased snow load could cause one tie member to fail. This horizontal member in the roof truss can be practically strengthened by bracing it against each neighboring tie. No other members required strengthening.

Rehabilitation of the building will bring new life to the space. As discussed during engagement interior changes could include raising the ceiling. Based upon condition assessment findings, it would be possible to rise the ceiling slightly, up to the next tie member. Building a ceiling at this height would also address the deficiency in the roof structure by bracing the vulnerable member to prevent buckling.

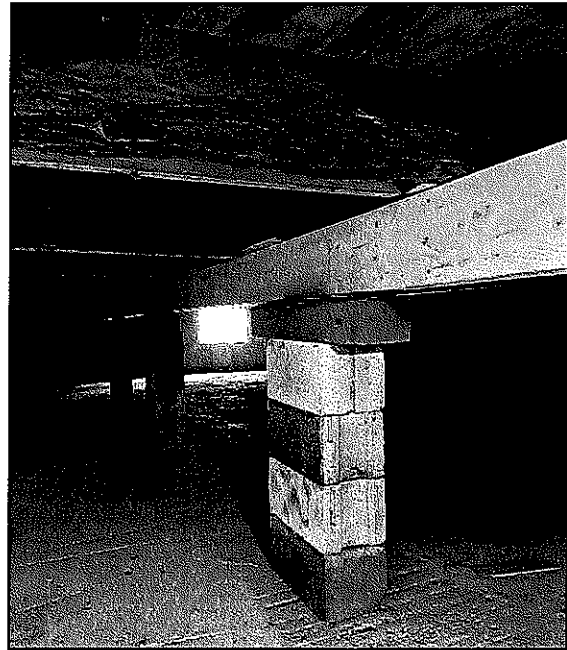
Figure 8: Ground floor supports

The ground floor structure was found to be in **poor** condition.

The central beam is undersized for potential future use as a public building. Additionally, the joists will require minor repairs before the building returns to use.

In terms of the centre beam, there are multiple practical approaches to addressing the deficiency, including adding additional supports or strengthening the member. The selected course of action will be influenced by if the basement space is to be used, and how.

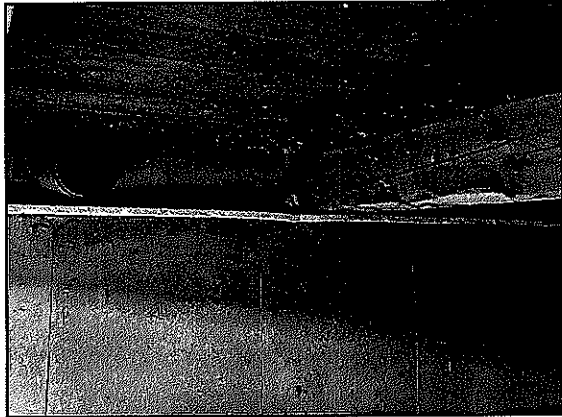
Figure 9: Styrofoam layer between foundation and sill

The Styrofoam bed between the foundation and the wooden sill for the building is not common practice. The Styrofoam would not have

adequate durability for long term use. Eventual failure of the Styrofoam would likely lead to non-structural damage to surfaces and operation of windows.

During the 2019 project a layer of Styrofoam insulation was placed between the wood sill and the concrete foundation. This is not a typically recommended practice and raises concerns regarding long term durability. There may have been a reason why this was done, and background information would be

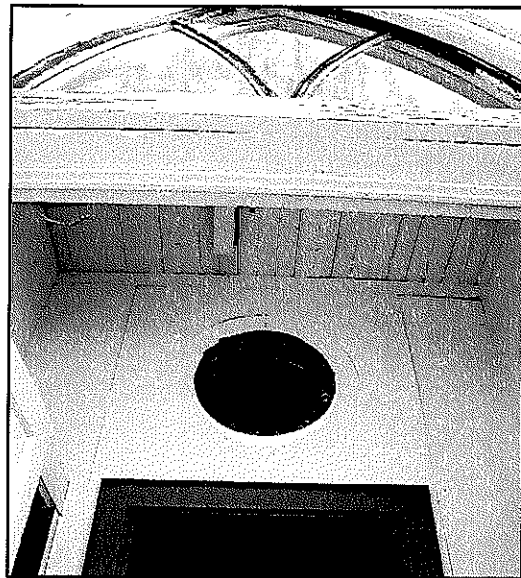
Figure 13: Opening for stained glass

The opening (Figure 13) creates an opportunity to create a new story and feature for the building. Commissioning a new stained-glass window to capture the importance of this new community space would be a natural and appropriate creation of a new character defining element.

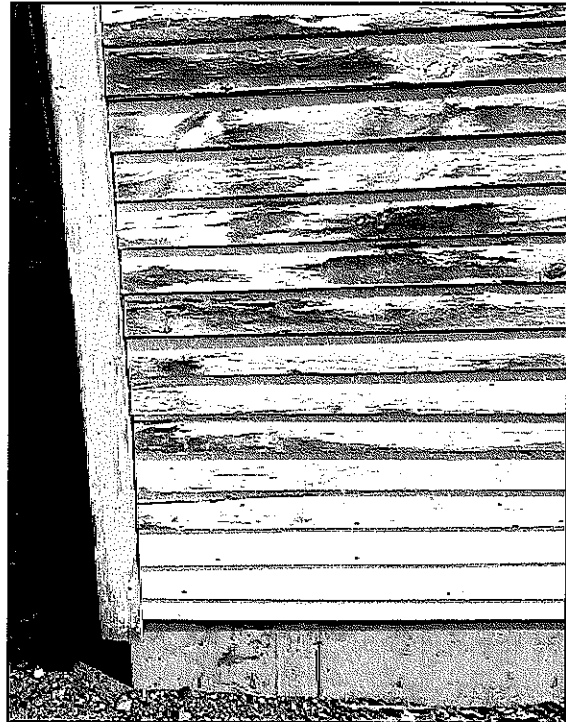
The siding at the bottom of the walls in the south-west corner has recently been replaced with newer boards. Exterior paint was found to be peeling from the siding (Figure 4). The exposed wood was observed to be very dry and will likely require rehydration prior to painting.

Figure 15: South-west exterior corner with new siding at the bottom and paint peeling from the siding above

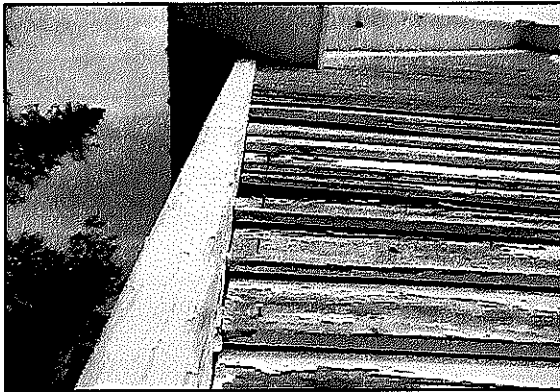
Figure 5 shows where some of the clapboards were cupping because of wood shrinkage. In some locations the boards have also cracked. Nails that were observed popping out of the wood boards could be related to shifting and settling associated with the building's relocation. It is recommended that prior to repainting damaged boards be fastened down or replaced as required.

Figure 16: Cupping clapboards and popping nails on southwest corner of structure

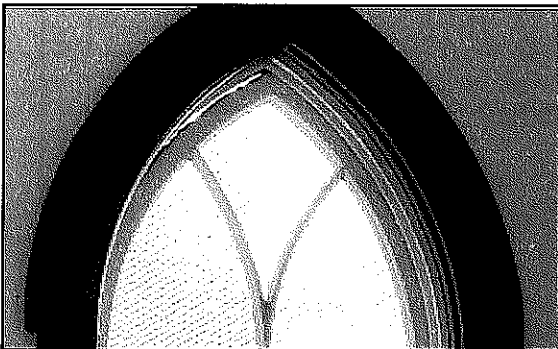
Figure 18: Slippage in southeast corner window

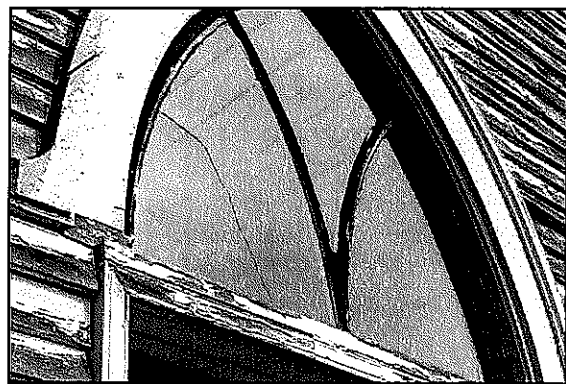
The front entrance to the building is located on the south side of the building and consisted of a double door with an arched transom. The window above the entrance is made of blown glass and was observed to be cracked on the lower western pane (Figure 8).

Figure 19: Cracked glass above entrance doors

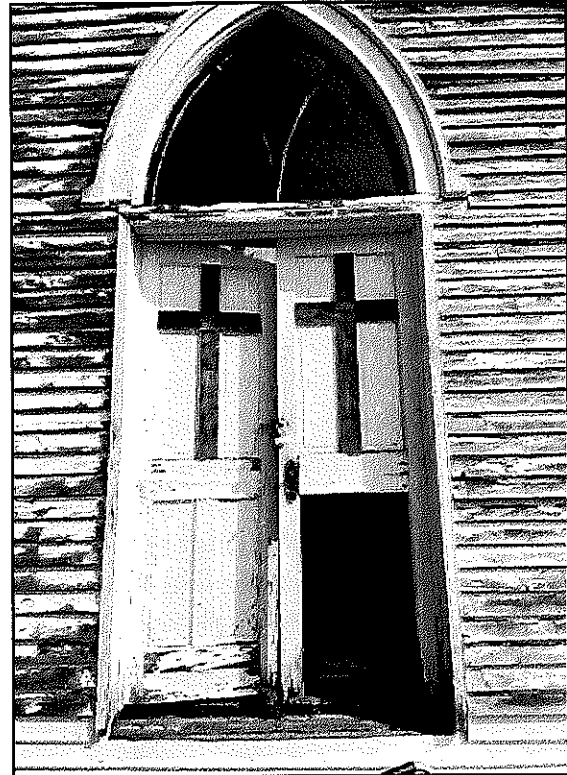
Figure 20: Missing door panel

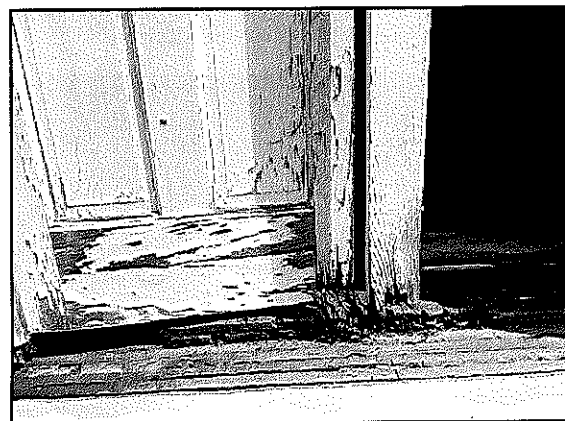
The door, door trim, and door frame were showing signs of rot, with the most significant deterioration visible on the bottom section of the door and threshold (Figure 10).

Figure 21: Deterioration on threshold and bottom of door

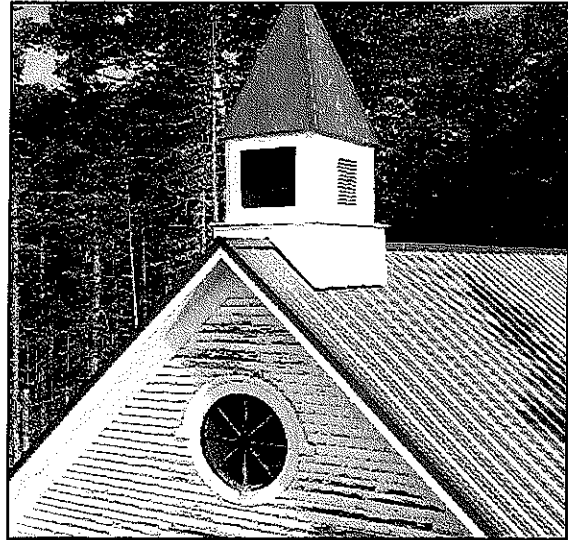
The small bell tower located at the south end of the roof was also clad in new metal roof material (Figure 11). Visual inspection could not confirm if the bell tower is structurally attached to the roof and no evidence of a connection could be found in the attic.

Figure 22: New metal roof with bell tower at south end

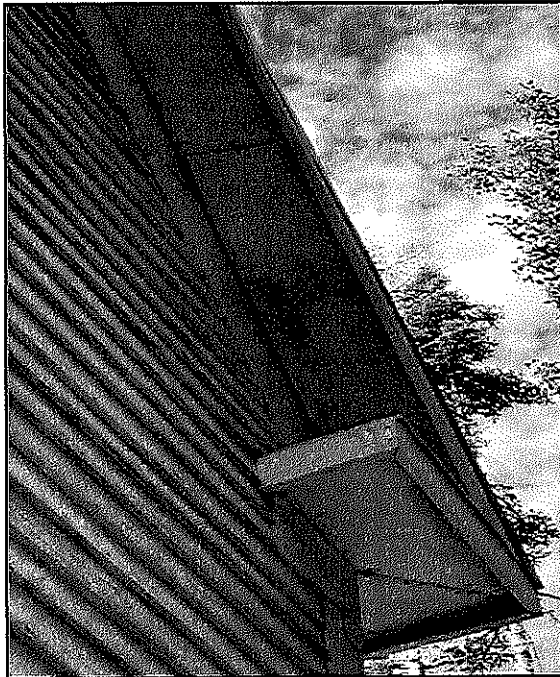
Figure 23: Wood soffits

On the weekend of December 5th & 6th, 2020, a large tree fell on the church and caused damage to the roof. As the site visits were prior to this damage occurring it was not possible to update. However, based upon information provided additional repairs to the roof and wood soffits will be required and have been identified by the municipality.

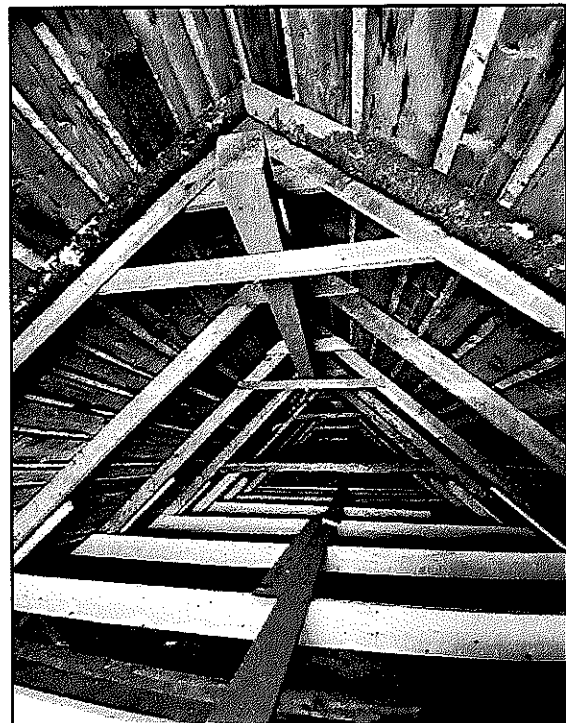
Figure 24: Roof structure

The roof structure consists of trusses spaced roughly 1.1 m (42.5") apart. Based on the appearance of the wood, the structure has been through several interventions in its lifespan (Figure 13).

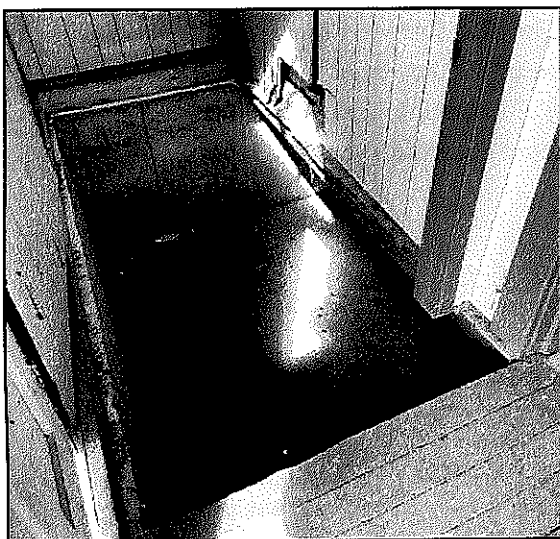
The basement was accessed by a temporarily placed ladder through the opening in the south-west corner (Figure 15). In its current form the opening is a safety hazard.

Figure 26: Basement access

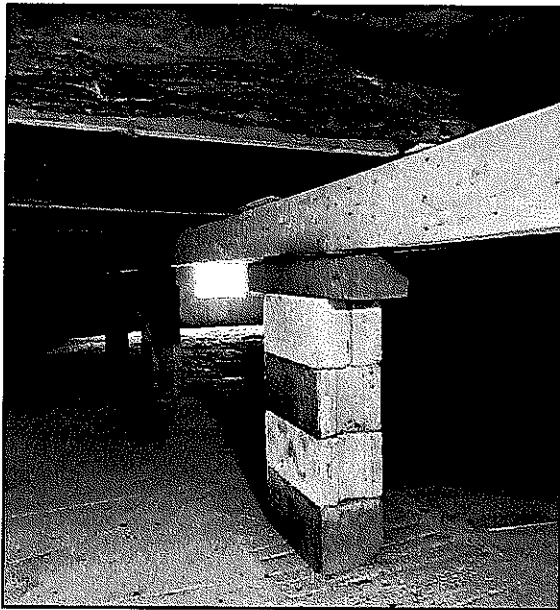
Deterioration was observed in the joists and some had been sistered with dimensional lumber at various locations. The checking in the joists occurs mostly towards the foundation walls. Additional reinforcement may be required.

Figure 27: First floor structure, showing columns, centre beam, and joists
