Hanwell Little Recreation Building

Condition Assessment and Visioning

Project J20219

HERITAGE STANDING INC.

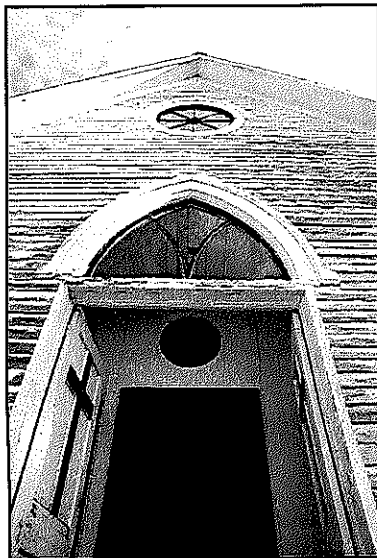
Figure 10: Entryway

The doors and door frame will require likely replacement. Windows and hatches are in good enough condition for repair.

The door, door trim, and door frame were showing signs of rot, with the most significant deterioration visible on the bottom section of the door and threshold (Figure 10).

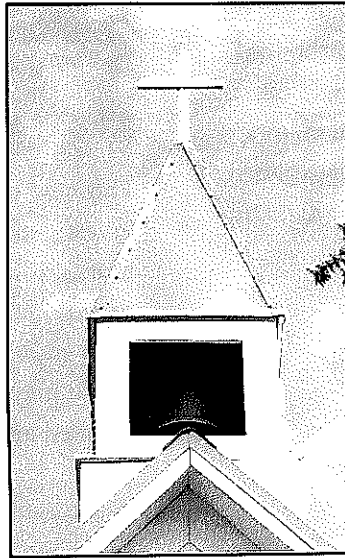
Figure 11: Belltower

The small bell tower located at the south end of the roof was also clad in new metal roof material (Figure 11). Visual inspection could not confirm if the bell tower is structurally attached to the roof and no evidence of a connection could be found in the attic.

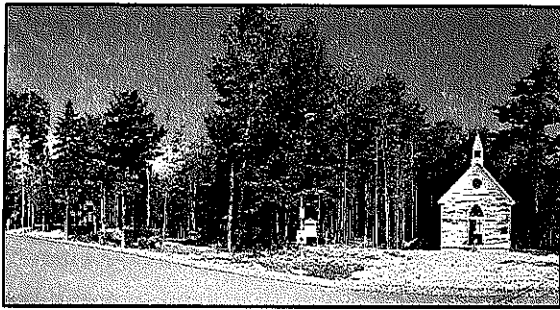
Figure 14: Little Recreation Building with Hanwell Nature Park to the west

The ground around the building was well graded overall, sloping away from the structure and so allowing for proper drainage of water. During the first site visit, there was a large pile of rock on the west side of the building, however it presented no immediate concern related to water drainage and had been removed prior to the second inspection. One potential area for poor drainage was identified on the north side of the building close to the basement hatch. Water could pool along the foundation wall and it is recommended that this area be regraded to ensure that water does not enter the structure.

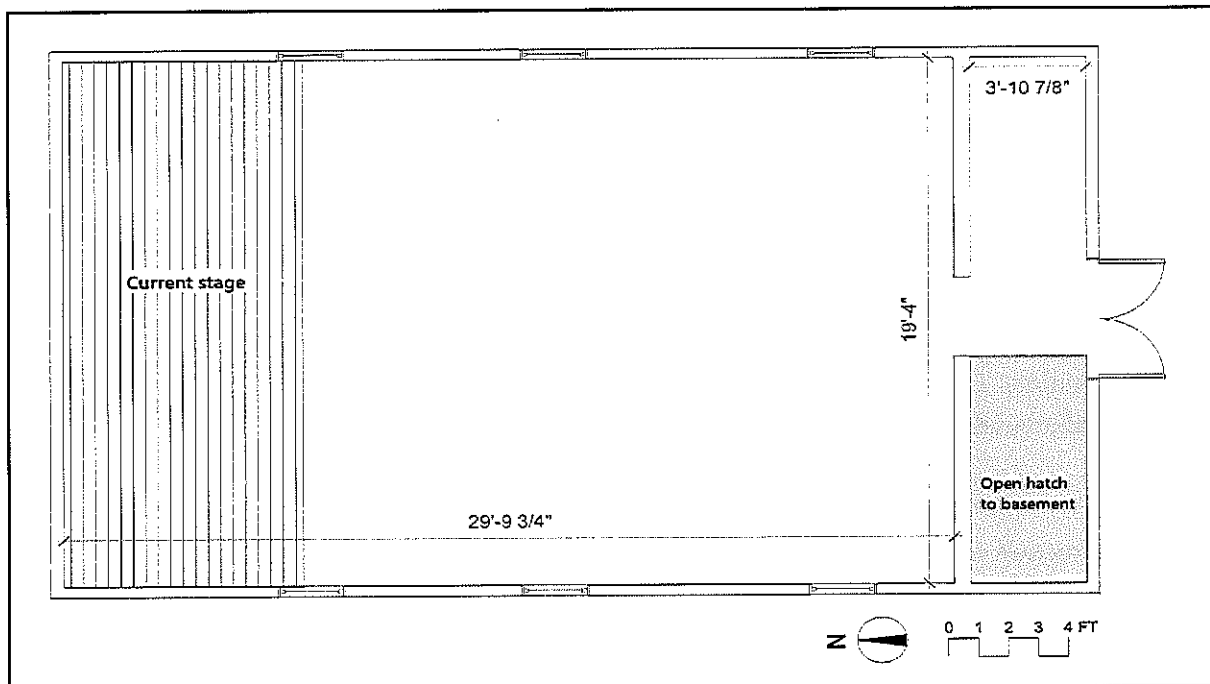
The wall structure was neither exposed nor evaluated; however, no evidence of deficiencies was present. The interior ceiling was composed of painted wood boards with peeling evident in a few localized areas, possibly due to moisture. The hardwood floors continued into the vestibule; however, the subfloor and hardwood were showing signs of deterioration around the front door and should be repaired.

Figure 25: Current ground floor plan of Little Recreation Building
